FIELD SERVICE BULLETIN

Navion

FIELD SERVICE BULLETIN NO. 22
15 NOVEMBER 1954

SUBJECT: INSPECTION AND/OR REPAIR OF CRACKS IN FUSELAGE
FRAME 143-31004-16 AT STATION 294. 1

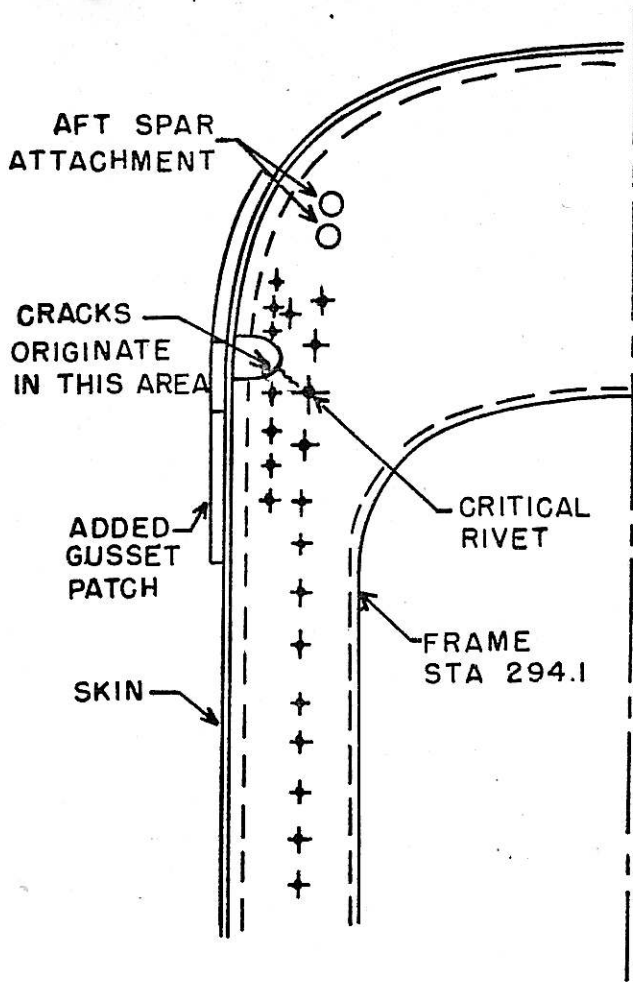
FIG. 1
LOOKING FWD

1. Inspection of some Navion aircraft has revealed that cracks may exist in fuselage frame 143-31004-16 at Station 294. 1 inboard from the top stringer cutouts at W. L. 21. 00. Immediate inspection of the area must be made by removing the inspection plate on the left side of the fuselage beneath the horizontal stabilizer, looking forward to view the aft side of frame at points in question. If no crack is visible, perform a thorough inspection of the frame at each 100 hour inspection thereafter.

2. If a crack is visible at either side of the frame, determine if it has extended beyond the critical rivet (see Figure 1) if so, it is necessary to apply paragraph 3, otherwise proceed as follows immediately.

- a. Remove stabilizer for access to bulkhead.
 - b. When crack extends to the critical rivet, remove the rivet and relocate nearby or if cracks does not extend as far as the critical rivet, stop-drill end of crack.
