Navion Service Bulletin No. 102
July 13, 2004

Subject	Airframe – Engine Mount
Effectivity	Serial Numbers NAV-4-002 thru NAV-4-2561 Engine Models all Continental IO-470, IO-520 & IO-550
Purpose	Suspect unapproved engine mount components have been discovered that failed to conform to FAA approved design data. These components are prone to fatigue failure.
Compliance	Mandatory
Description	<p>The Navion Part Numbers for the suspect unapproved parts are 147-30007-3, 147-30007-4, 147-30007-5, 147-30007-6, 147-30010-1, 147-30010-2, 147-30006-3, and several doublers on the 147-30001-SA1 assembly. Suspect parts can be identified by one of the following methods:</p> <ol style="list-style-type: none">1. 147-30007-5 & 147-30007-6 supports have insufficient edge distance on the five bolt holes in their lower portions. Any support with edge distance less than 0.240” is considered suspect. Thickness less than 0.650” is also considered suspect. Hole diameter other than 0.125” is considered suspect.2. 147-30010-1 & 147-30010-2 castings have incorrect material composition, and do not conform to approved drawings. Any casting with a chamfer instead of a rounded corner at the single hole on the narro

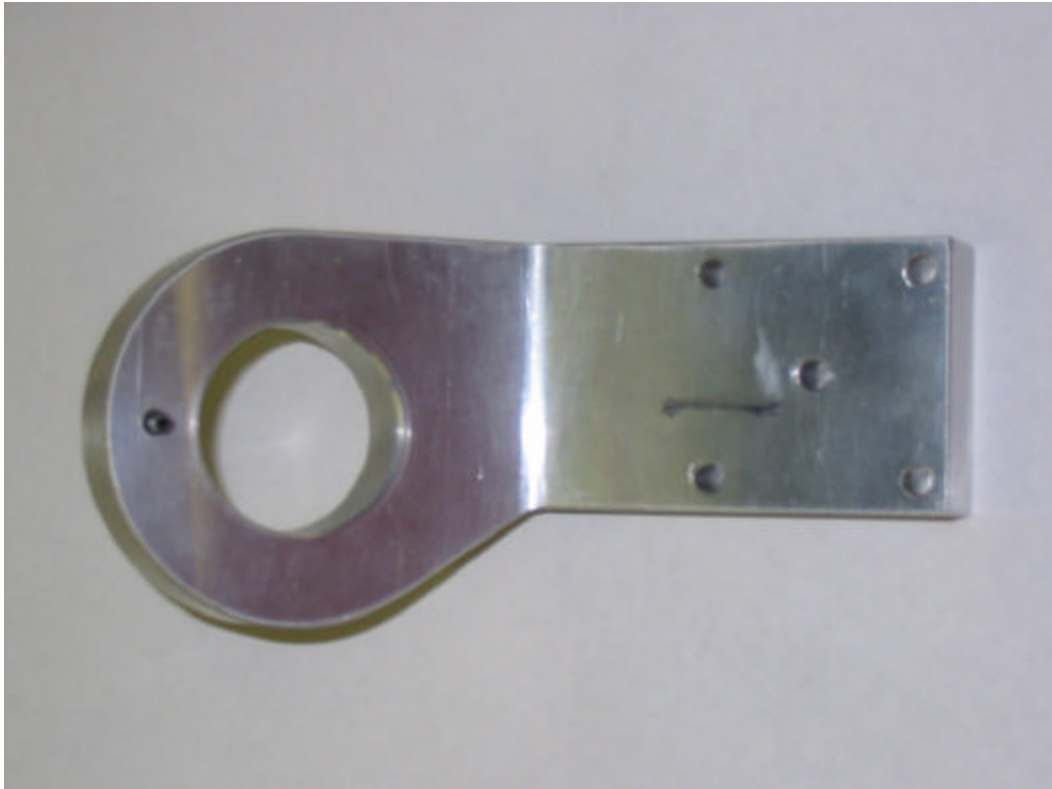
Figure 1: Sample Support with Insufficient Edge Distance

If any part is considered suspect, all parts of the engine mount are considered suspect and should be inspected for conformity. Engine mounts which fail to conform must be replaced.

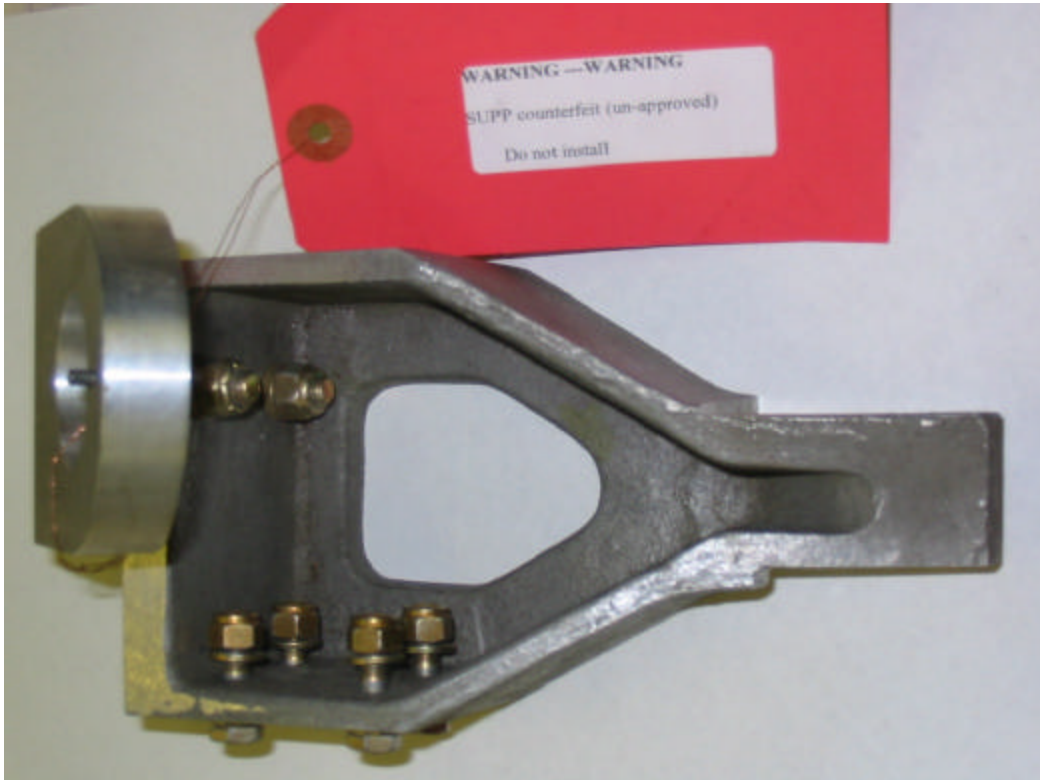
Figure 2: Casting Showing Improper Machining & Inconsistent Wall Thickness

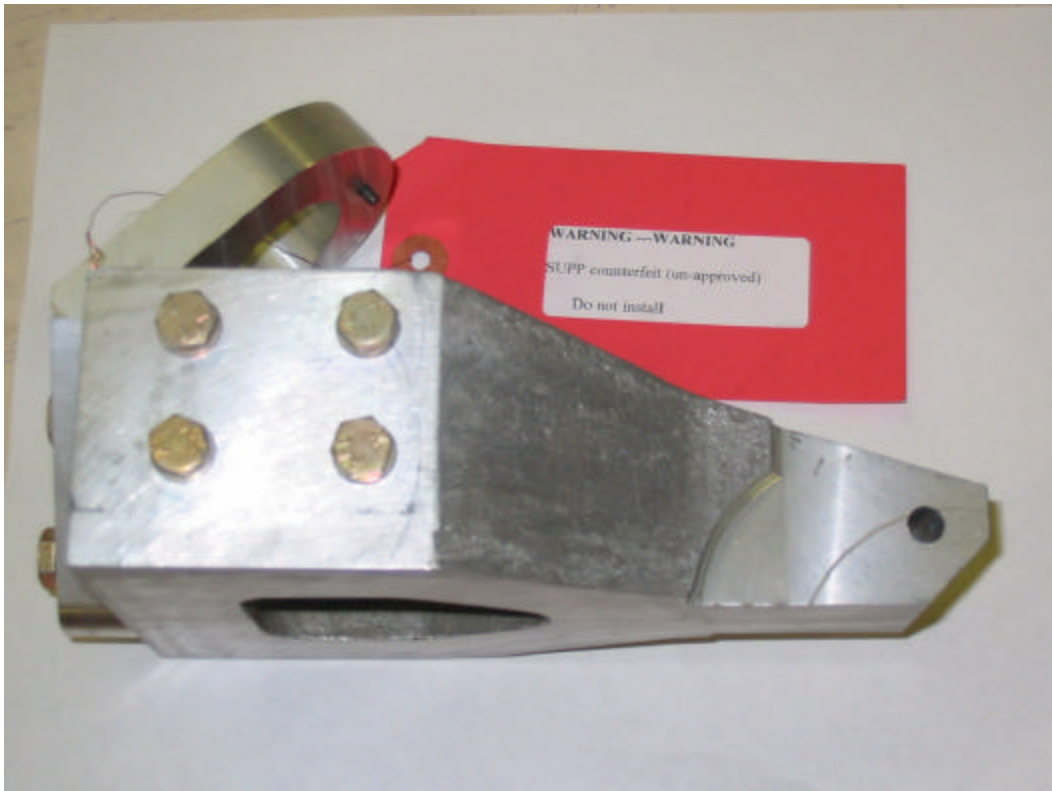
Figure 3: Casting Showing Improper Machining & Chamfer Instead of Radius
