Navion Service Bulletin No. 103A
July 17, 2009

Subject	Airframe – Fuselage Reinforcing Kit
Effectivity	Serial Numbers NAV-4-002 thru NAV-4-2561
Purpose	Unapproved fuselage beef-up components have been discovered that fail to conform to FAA approved design data. These components, when installed as fuselage structural reinforcements for the installation of the Lycoming GO-435, Continental IO-470P, IO-470C, IO-470H & IO-520B BA BB and higher Horse power and displacement engines installed, fail to meet strength requirements.
Compliance	Mandatory
Description	<p>The Navion Part Numbers for the unapproved parts are 145-31102-XX. Unapproved parts can be identified by one of the following methods:</p> <ol style="list-style-type: none">1. All 145-31102-XX fittings should be stamped out of a single piece of steel. Unapproved parts will have secondary pieces of varying size and shape of made unknown ferrous material welded inside the front flange near the large bolt hole. Suspect parts will also have welded joints of poor quality along the edges of the same flange. Wall thickness different than 0.109” ±0.010” fails to meet strength requirements or conform to approved design data. Inner width

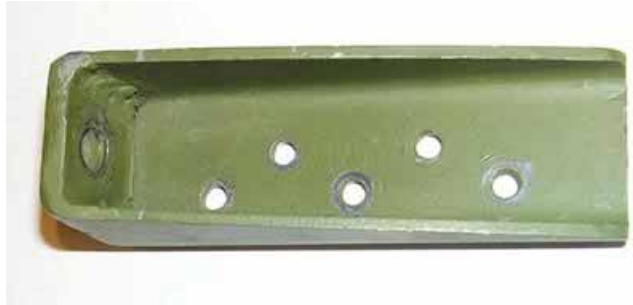
Figure 1. Sample 145-31102-XX fitting suspect part

NOTE:	If any part fails to meet strength requirements or conform to approved design data, all parts of the kit are considered unapproved and should be inspected for conformity. Kits which fail to conform should be replaced or field approval obtained.

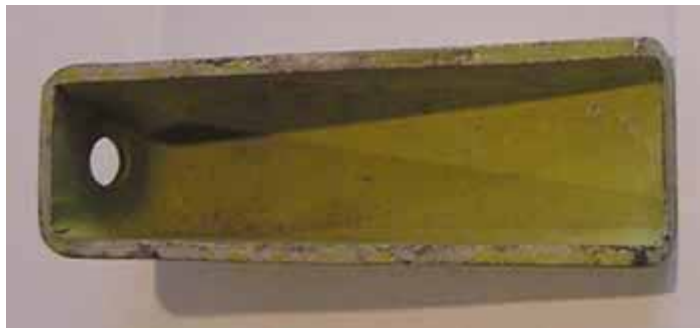
Figure 2. Sample 145-31102-XX fitting approved, original configuration up to 185 HP

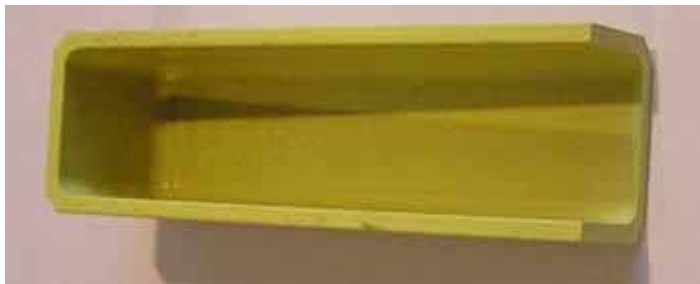
Figure 3. 145-31102-1001 Fitting, preferred
