Navion Service Bulletin No. 109

Subject: Frame Assembly Station 311.07 Inspection:

Models Affected: All Navions, Serial Numbers NAV-4-002 through NAV-4-2561

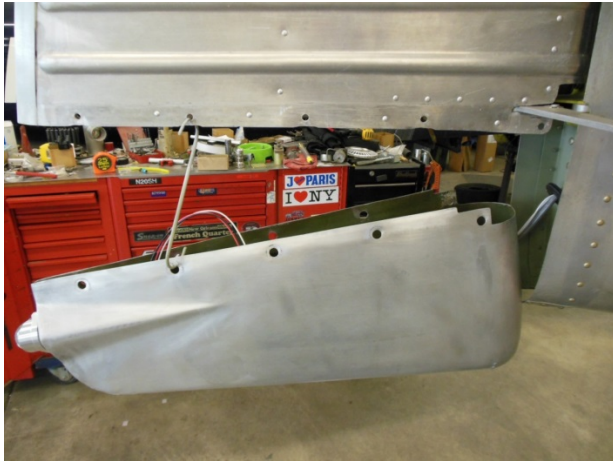
Figure 1a

Figure (1a) shows aft rudder fairing removed to facilitate inspection. Figure (1b) shows left side access panel at Fuselage Station 302 with panel removed.

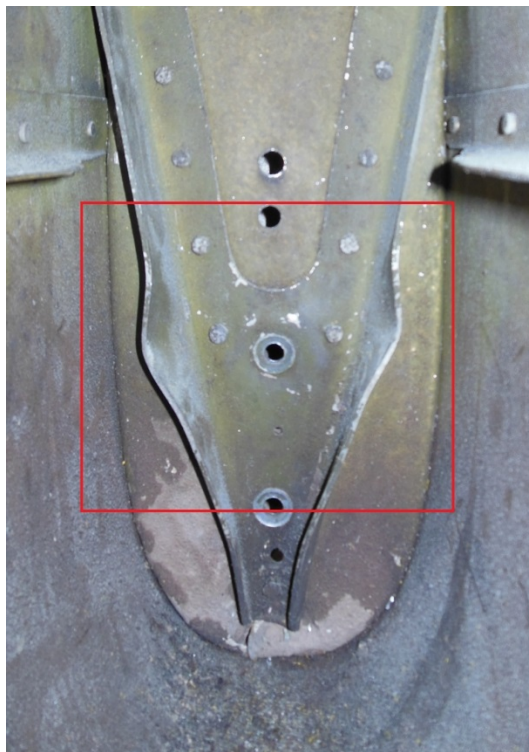
Figure 2a

Figure (2a) illustrates the inside (fore) of a damaged Fuselage Station 311.07 frame assembly. Red box indicates the affected area (Part No. 143-31004-7). Figure (2b) illustrates undamaged frame assembly.

Action: If the frame doubler or web is found to be cracked or distorted beyond '*negligible damage*' as described in the Navion Structural Repair Manual (SRM) paragraph 4-47, (4-25), the affected components must be replaced in accordance to paragraph 4-48 of the SRM. Reference Figure (1) through (9) below. **Please contact SHA for any technical support, parts support or any general inquiries that may arise during the inspection procedure at info@navion.com or +01 651-306-1456.**

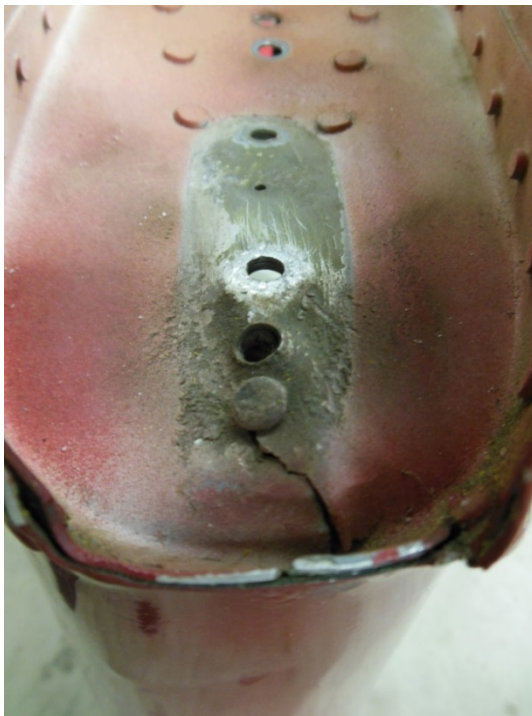
Figure 3a

Figure (3a) illustrates the outside (aft) of a cracked Fuselage Station 311.07 frame assembly (Part No. 143-31004-7). Figure (3b) illustrates undamaged frame assembly.

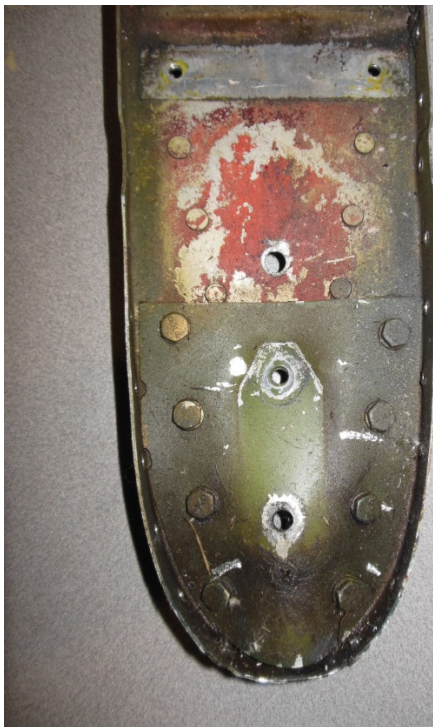
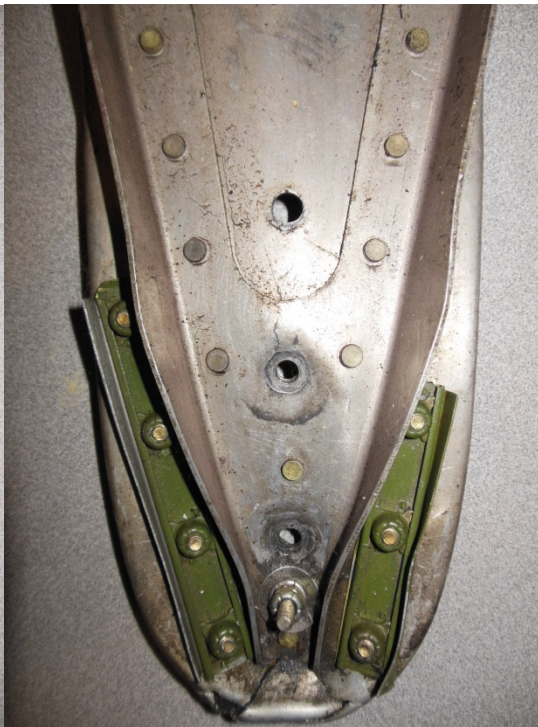
Figures (4a) and (4b) illustrate non-standard repairs installed with damage to web and doubler still remaining, requiring replacement of the assembly (Part No. 143-31004-7).
