NAVION AIRCRAFT COMPANY

SERVICE LETTER NO. 85

SUBJECT: Loose rivets through wing skin and stringers

EFFECTIVITY: Ser. No. NAV 4-2 & Up; NAV 4-2351 & Up.

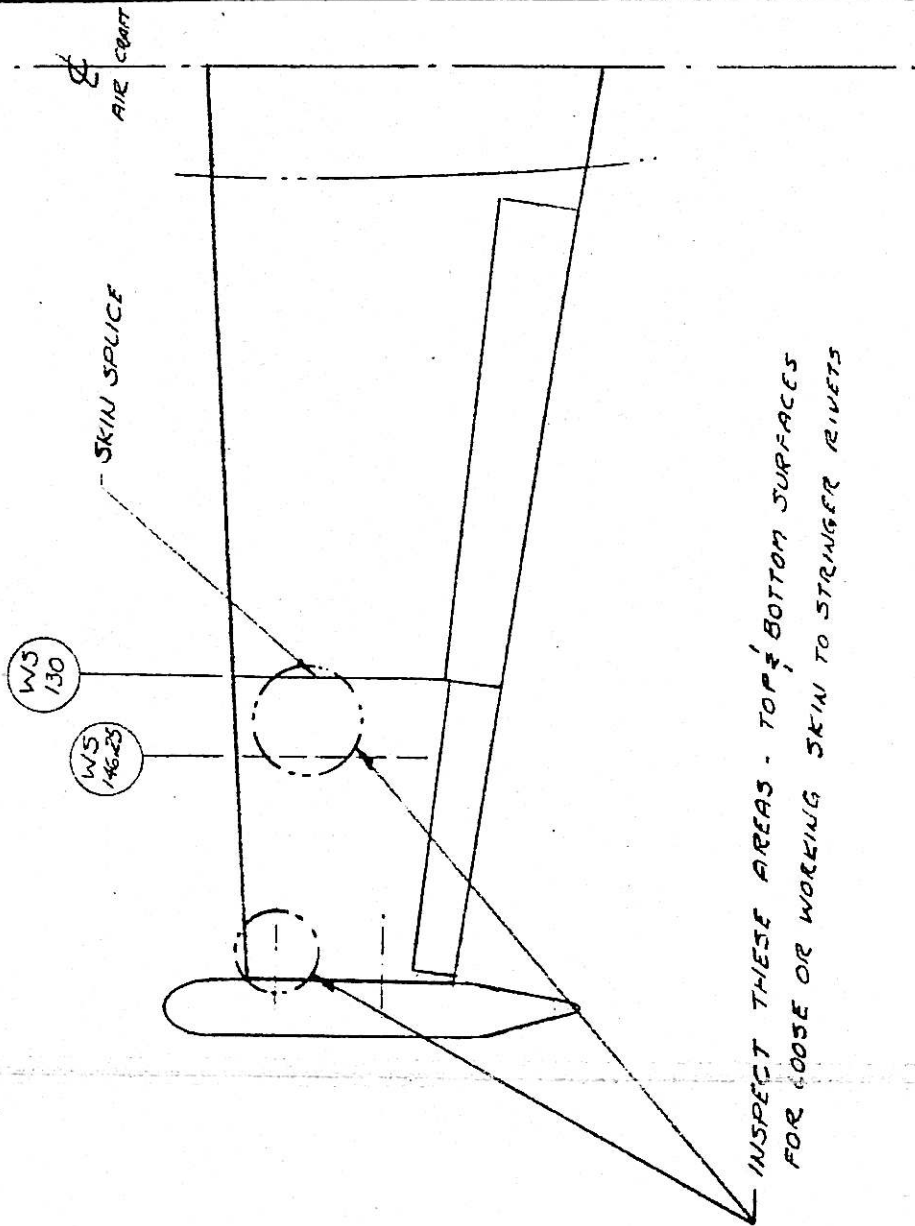
*FIG. NO. 1 - SERVICE LETTER BS*

Field reports indicate several occurrences of wing skin to stringer rivet loosening in some areas. This loosening may possibly be caused by hard landings with full tip tanks.

The areas indicated on attached Fig. 1 should be visually inspected for working rivets. Loose rivets should be removed and the next larger size rivet installed. If it is impracticable to install the next larger rivet, due to lack of edge distance or interference, the number of rivets should be increased through the affected area, by adding an additional rivet between each loose rivet and the next adjacent rivet. It is recommended that the additional rivets be of the protruding head type.
