MAINTENANCE

Tips for the Aging GA Fleet

With proper maintenance and upgrades most will continue to operate in a safe airworthy condition well into the future

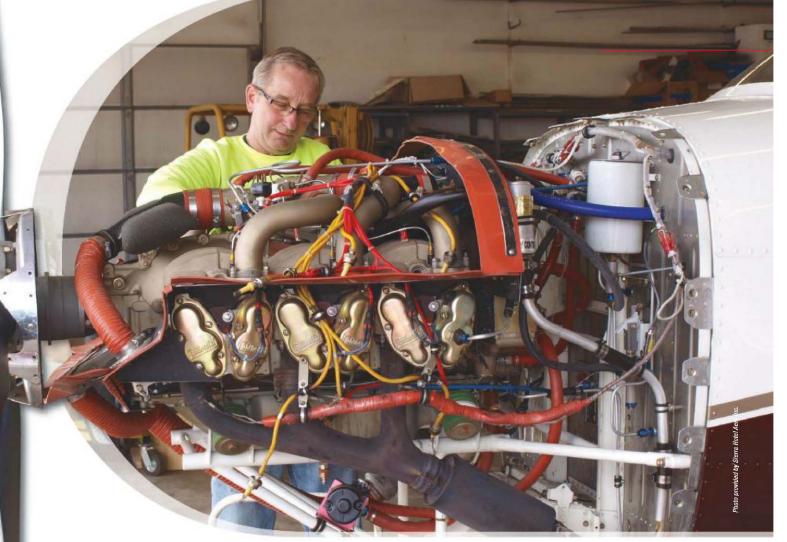
Anyone working on older GA aircraft have experienced the aftermath of rodents when aircraft sit idle.
