Navion Service Bulletin No. 106 A

Subject: Fuel System- Inspection of the fuel system continued safe operation. This is due to several recent Navion accidents caused by improper inspection and maintenance of the fuel system and related components. **ALL SERVICE BULLETINS REFERENCED CAN BE ACCESSED AT: <http://www.navion.com/servicebulletins.html>**

Effectivity: All Navions, Serial Numbers NAV-4-002 thru NAV-4-2561 regardless of model designation.

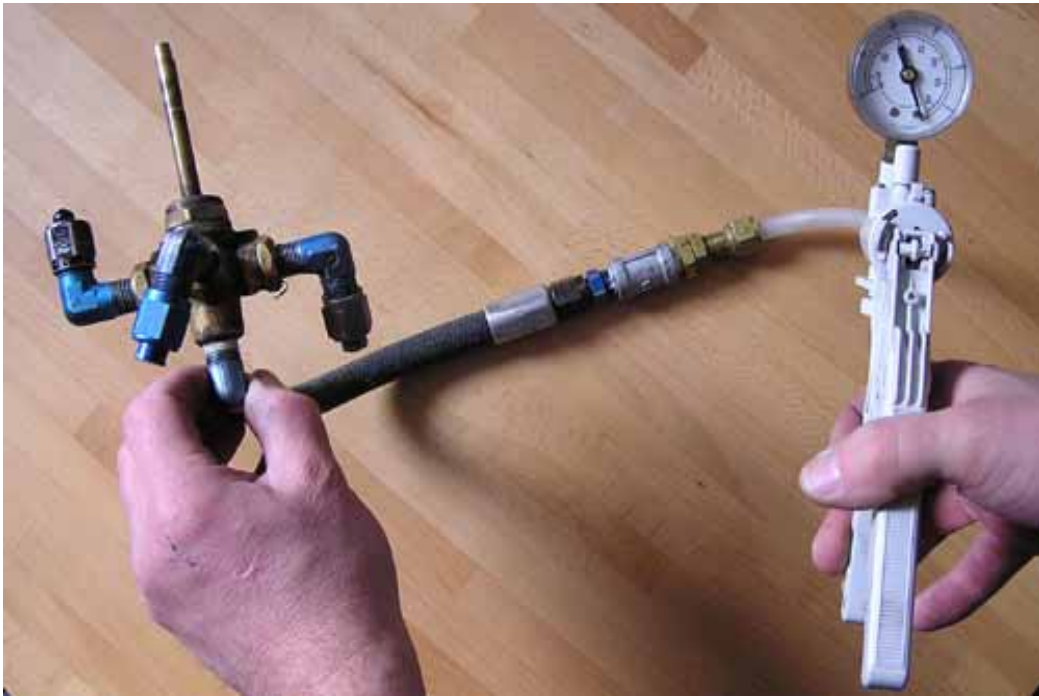
Figure 1- Typical Valve Vacuum Test

- 4. Perform the following vacuum test to detect external leakage:
  - a) Plug all inlet ports using AN922-6D or equivalent caps.
  - b) Connect hand operated vacuum pump to outlet port and apply 24" of vacuum as follows; Ref. Fig 1
  - c) With valve in the off position apply 24" of vacuum for 1 minute, note bleed down.
  - d) Repeat step (c) for all remaining positions.

- a) Plug all inlet ports but one (e.g.; MAIN) using AN922-6D or equivalent caps.
- b) Connect hand operated vacuum pump to outlet port and apply 24" of vacuum as follows; Ref. Fig 1
- c) With valve in the off position apply 24" of vacuum for 1 minute, note bleed down.
- d) Repeat step (c) for all remaining positions except the open line.

If more than 1" of bleed down is noted in 1 minute, selector valve must not be returned to service and must be replaced in accordance with Service Bulletin 101A before further flight.

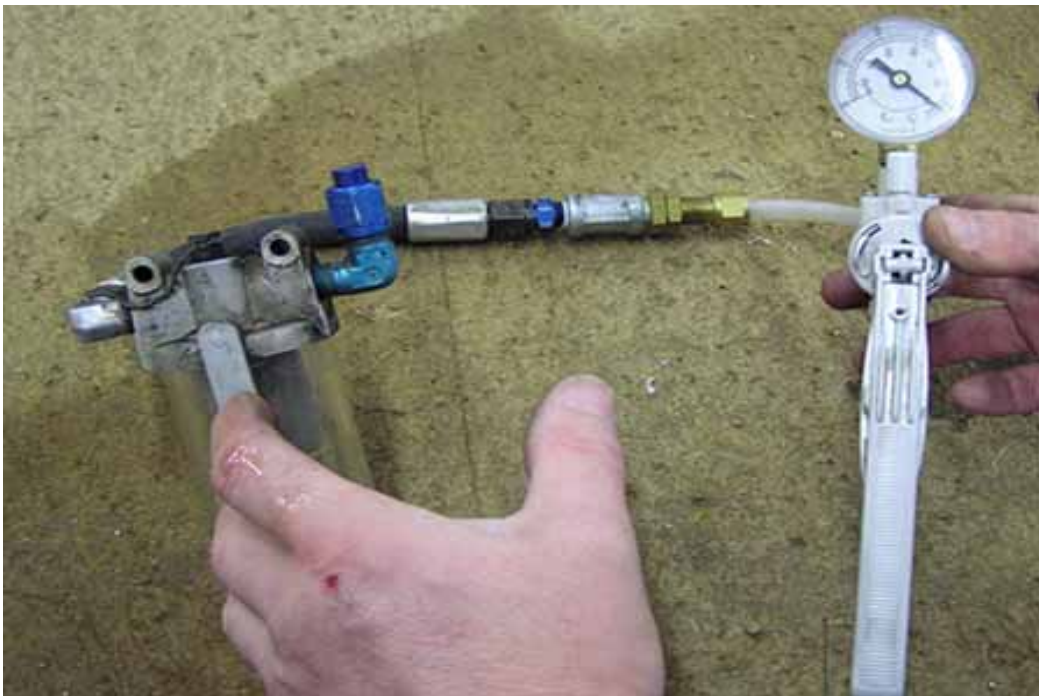
Figure 2 Typical Gascolator Vacuum Test

Perform Vacuum test of Gascolator :

- a) Plug outlet port and primer port as needed
- b) Connect hand operated vacuum pump and apply 24" of vacuum. (Ref Figure 2)
- c) Verify bleed down does not exceed 4" over one minute.
- d) Replace gaskets, fuel drain and/or gascolator as needed to ensure proper operation. (Reference Parts Manual January 01, 2006 or later Revision.)
